**DEPARTMENT OF TRANSPORTATION**

Contract #: 04-0120F4Cty: SF/ALA Rte: 80 PM: 13.2/13.9File #: 69.28**WELDING INSPECTION REPORT****Resident Engineer:** Pursell, Gary**Address:** 333 Burma Road**City:** Oakland, CA 94607**Report No:** WIR-007126**Date Inspected:** 16-Apr-2009**Project Name:** SAS Superstructure**OSM Arrival Time:** 700**Prime Contractor:** American Bridge/Fluor Enterprises, a JV**OSM Departure Time:** 1900**Contractor:** Zhenhua Port Machinery Company, Ltd (ZPMC), Changxing Island **Location:** Shanghai, China**CWI Name:** Sun Wei / Sun Bo**CWI Present:** Yes No**Inspected CWI report:** Yes No N/A**Rod Oven in Use:** Yes No N/A**Electrode to specification:** Yes No N/A**Weld Procedures Followed:** Yes No N/A**Qualified Welders:** Yes No N/A**Verified Joint Fit-up:** Yes No N/A**Approved Drawings:** Yes No N/A**Approved WPS:** Yes No N/A**Delayed / Cancelled:** Yes No N/A**Bridge No:** 34-0006**Component:** OBG Components**Summary of Items Observed:**

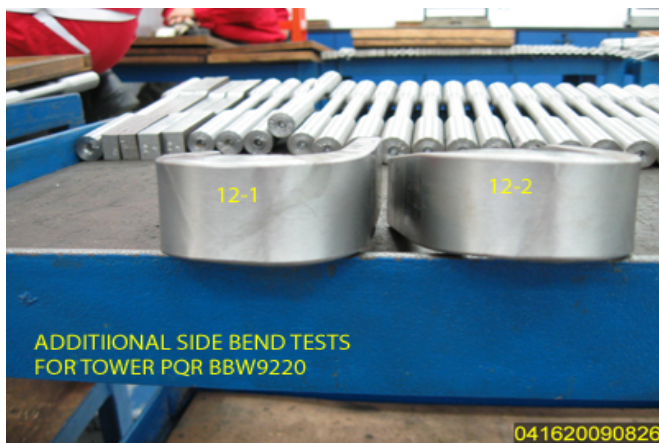
The QA Inspector witnessed mechanical testing for ZPMC Welding Procedure Qualification Test (WPQT) HP2009220 Specimen BBW220 with ABF Representative Craig Knops. Two additional side bends had to be cut, prepared and bent. Both side bends BBW9220-12-1 and BBW9220-12-2 were acceptable. The attached photograph provides additional detail.

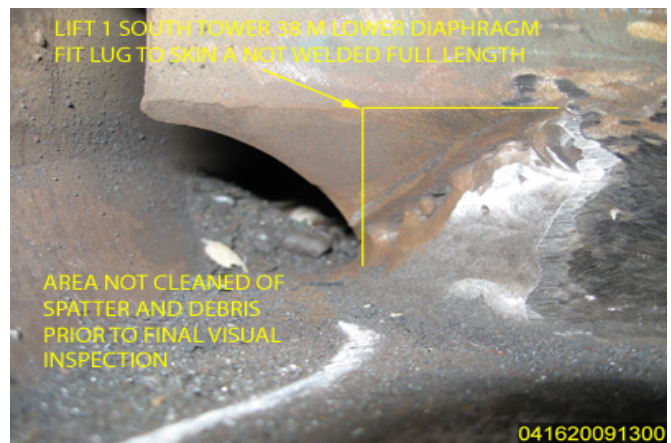
The QA Inspector attempted to perform a 100% Visual Inspection (VT) of the welds attaching the fit lugs to Lift 1 South Tower 9M, 38M Upper, 43M and 47.6M Diaphragms to Skin Plate A per ZPMC NDT Inspection Notification Sheet 002676. There were several areas that were not ready for inspection. ZPMC Quality Control informed the QA Inspector that he would notify him when the re-work was completed. The attached photograph provides additional detail.

The QA Inspector performed a 100% Visual Inspection (VT) of the welds attaching the fit lugs to Lift 1 South Tower 9M, 38M Upper, 43M and 47.6M Diaphragms to Skin Plate A per ZPMC NDT Inspection Notification

Sheet 002676. There appeared to be no indications after the re-work and the QA Inspector accepted the above listed welds.
